## Product Alert 190502

**Subject:** Potential disengagement of Gear Box Drive Adapter from Plug Valve Plug

## DISASSEMBLY & REASSEMBLY OF GEAR OPERATED 3" & 4" LOW TORQUE PLUG VALVE ASSEMBLIES WITH 'GROP-DT36-BUSHING'

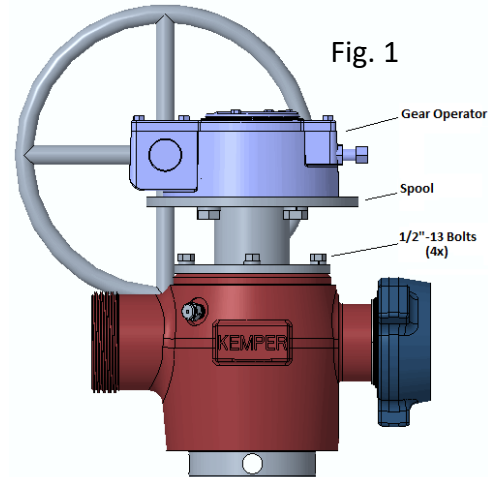
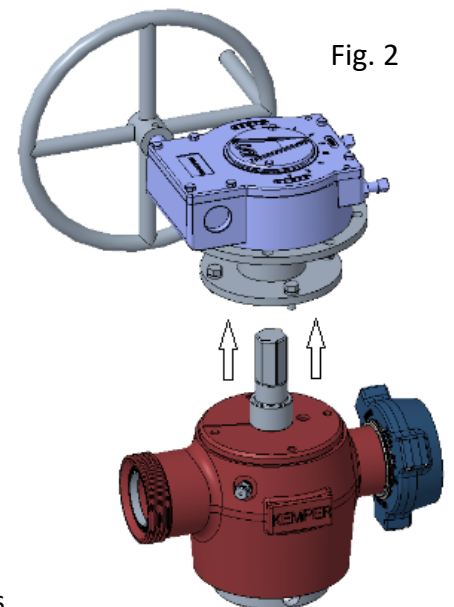
1. Secure Gear Operated Plug Valve Assembly to suitable work station in the vertical position
  - Note Serial # of valve assembly and handwheel position
2. Open valve completely by rotating hand wheel counter-clockwise until wheel stop is contacted.
  - Visually verify that valve is open by looking through flow bore
3. Remove the four 1/2"-13 grade 8 bolts that attach Spool to Plug Valve Body (Fig. 1)
  - Do not remove bolts that attach gear operator to spool
  - Note orientation of handwheel to nut/female end for reassembly
4. With assistance lift Gear Op and Spool vertically 12" to disengage from Gear Box Drive Adapter (Fig. 2)
  - Set aside on clean surface

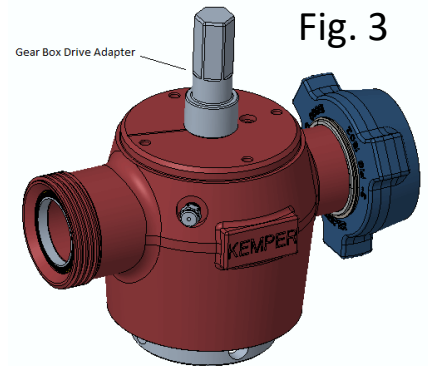
1. Ensure Gear Box Drive Adapter is installed onto the Plug Hex End (Fig. 3)
  - 3" Valve shown, 4" slightly different
2. Install (by hand) GRO-P-DT36-BUSHING over hex end of Gear Box Drive Adapter (Fig. 4)

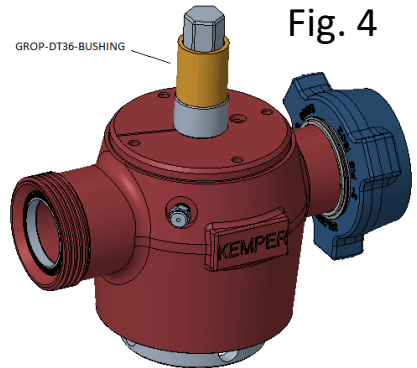
- Bushing will be loose fitting, must bottom out on adapter as shown
3. Maintaining the same orientation as disassembly, re-install Gear Operator and Spool by lowering vertically onto Gear Box Drive Adapter (Fig. 5)
